TOM & GINNIE HOWARD BRIDGE

SUGGESTED DESIGN SK-1.1 SUPERCEDES SK-1

EGLT
TOM & GINNIE HOWARD BRIDGE
SUGGESTED FOOTING

On December 2, 2022 I performed an onsite investigation of the soils at the site of the proposed wooden walking bridge on the Howard Preserve. The crossing site consists of a transect from an upland area dominated by sloping non-wetland soils formed in sand and gravel deposits, that then crosses a wet side channel of an unnamed tributary, and then floodplain soils on the edge of the agricultural field dominated by floodplain soils. I examined the soils in greater detail than shown in the USDA NRCS Soil Survey. I offer the following additional information on the soils in the crossing from East to West:

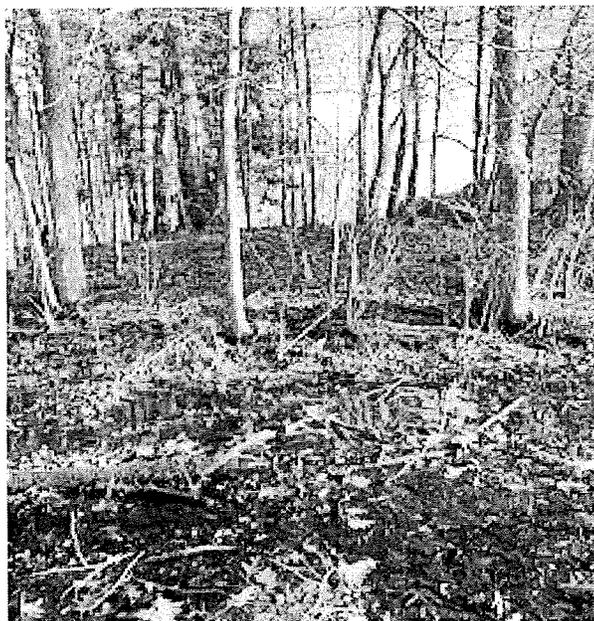
The proposed crossing is on the back side of the floodplain, and includes crossing a shallow mucky woody debris filled channel associated with an intermittent watercourse. There was no evidence of significant scour, and finer textured soils would indicate there is low energy from any flooding events. Below is a picture of the crossing area, with the blue flag barely visible to the east in the center of the picture.
